SMYRNA

Elementary School

Certificate of Necessity

Project No.: 18047
August 09, 2019

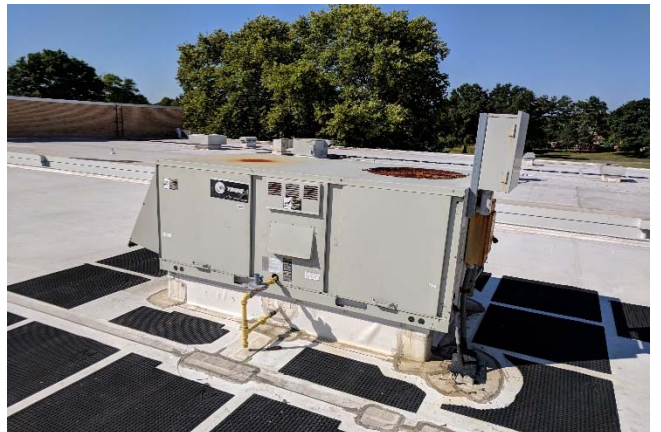
Photo #8 RTU Serving Library

- (3) packaged DX RTUs serving the Gym, Cafeteria and Library have been underperforming and require frequent maintenance due to their age. All (3) units should be replaced.
- All (4) Energy Recovery Units (ERU) have been underperforming and require frequent maintenance due to their age. These ERUs are installed to exhaust classrooms and provide “fresh air” ventilation to corridors. Existing drawings indicate that design airflows and leaving air conditions that are typically not recommended for this application and space type. The cost estimates provided are to replace these units “in-kind” as requested by maintenance staff. **However, we recommend further investigation and possible re-design before replacing these units.**
- Per maintenance schedules, all Unit Ventilators are due for refurbishment.

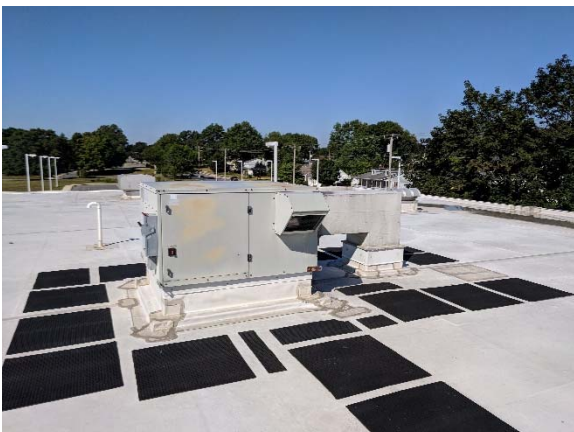
Photo #9 Typical Energy Recovery Unit

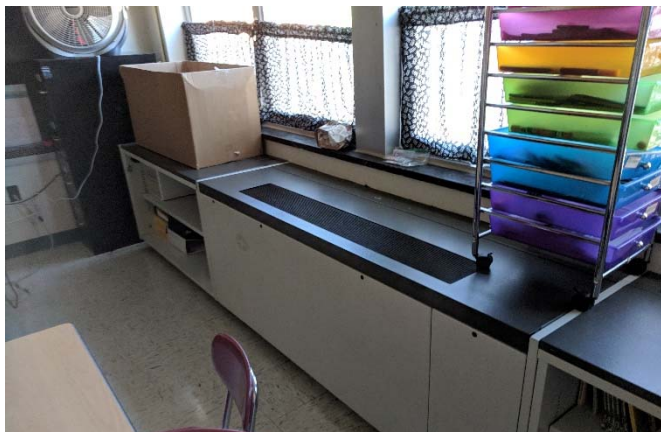
Photo #10 Typical Unit Ventilator

However, since there is already a central chiller and boiler in place with useful remaining service life, it is unrealistic to recommend a complete system replacement. The best compromise is to modify existing UV controls to only provide space cooling (no ventilation) with economizer function. New Energy Recovery Units (ERU) would be installed on the roof or in mechanical mezzanines. This system modification maximizes the use of existing equipment while decoupling ventilation and should be considered a mid-term solution until the next major renovation.

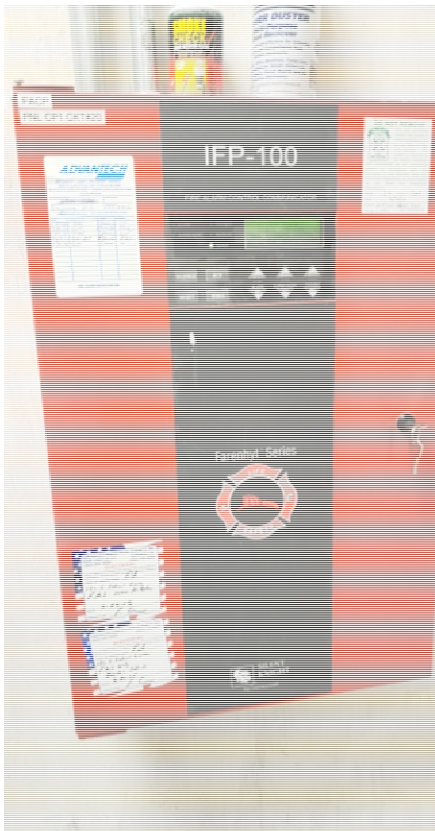
Photo #2 Fire Alarm Control Panel

There are no immediate or significant repairs that need to be made to the building fire alarm system. Routine and periodic testing and maintenance of the fire alarm system is recommended. While the existing fire alarm is in good condition, it utilizes audible horns and visual strobe notification devices and does not have a voice evacuation system. The 2015 NFPA 101 Life Safety Code requires that any new schools with 100 or more occupants have a fire alarm system utilize an emergency voice/alarm communications system to notify occupants. Even though a change is not required now, if a major renovation was to occur to the existing school, then the existing fire alarm system would need to be upgraded to a voice evacuation system.

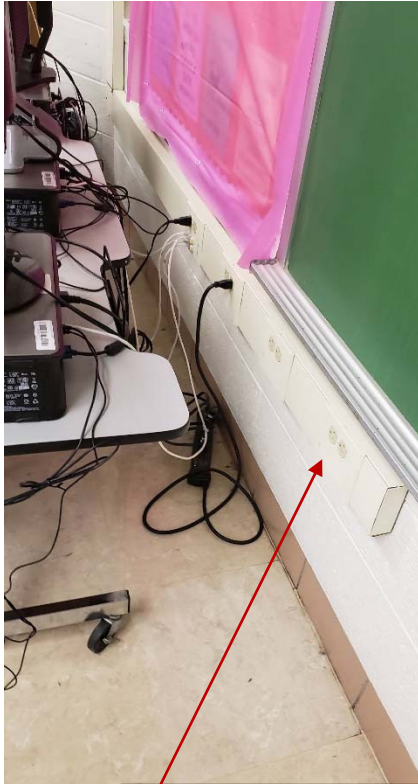
While the building appears to be in good condition, the recessed receptacles installed in the building are beginning to show signs of aging. Over the years, additional receptacles have been installed using surface metal raceway. We would assume that the building wiring to the recessed receptacles are the same age as the receptacle, so both would probably need replacement within the next 5 years. In addition, the current National Electrical Code (NEC) requires that all child care facilities have tamper resistant receptacles. The code defines a child care facility as a building or portion thereof, for educational, supervisory, or personal care services for more than four children 7 years old or less. So, this elementary school would fit this definition so we would recommend that all non-locking-type 125V, 15 and 20 ampere(A) existing receptacles be replaced with tamper-resistant receptacles. Many of the exterior disconnects are showing signs of rusting, so we would recommend that new NEMA 4X, stainless steel disconnects be provided for all exterior HVAC equipment that is replaced. The technology department has some planned improvements for buildings special systems as outlined below in the planned improvements section of this report.

Photo #5 Receptacle in Surface Mounted Raceway

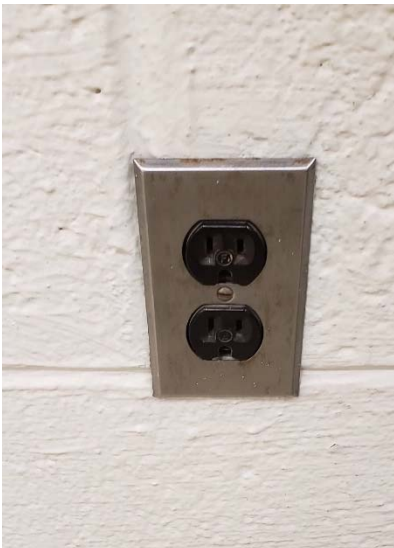
Photo #18 Typical Receptacle

1. Replace all existing building non-locking-type 125V, 15 and 20 ampere receptacles with tamper-resistant receptacles to comply with the current National Electrical Code.
2. Upgrade Fire Alarm system to voice evacuation system to comply with current NFPA 101 Life Safety Code.

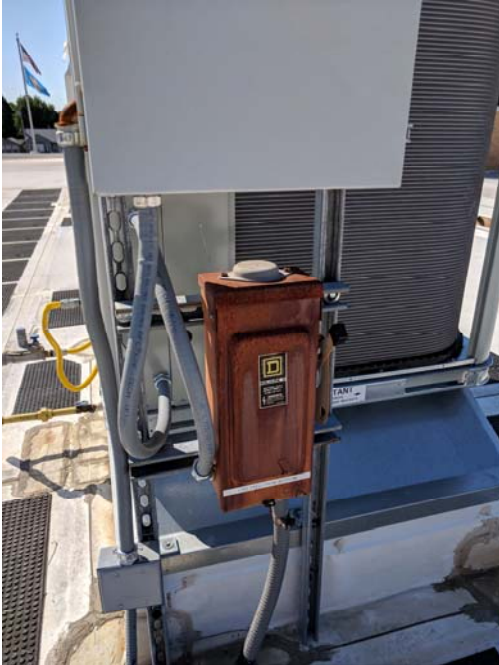
Photo #21

AHU-2 Rusted Disconnect Switch (B)

- Replace exterior disconnect switches for all exterior HVAC units that are replaced.

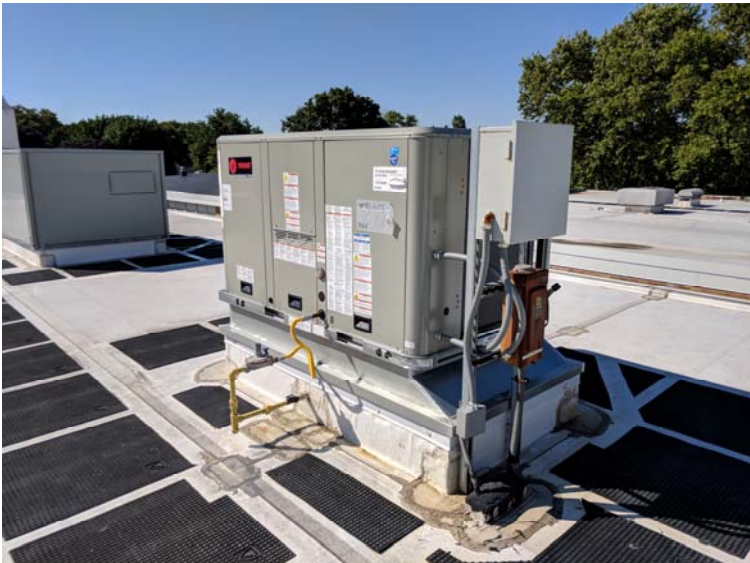
Photo #22

AHU-2 Rusted Disconnect Switch
